Draft Resource Management Plan

Chestnut Hill Reservation

Boston, Massachusetts

March 22, 2006

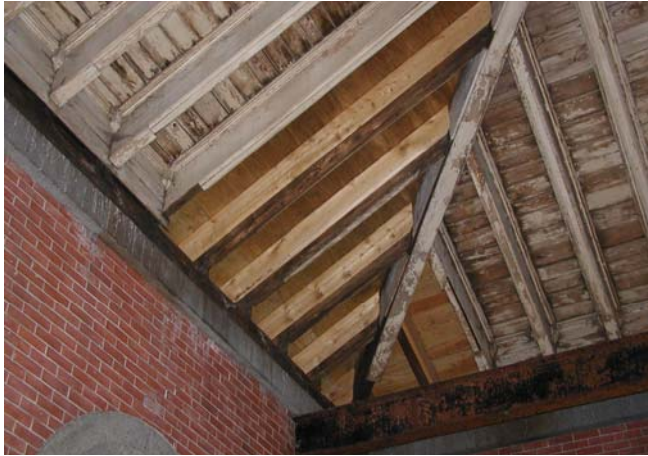
While the roof is in good condition overall, it should be assumed that there is some moisture damage in the decking and possibly the rafters at the four corners. The roof structure would need to be repaired before the building could be designated for public use.

Figure 3.9: Modern materials in southwest corner of roof (2005)

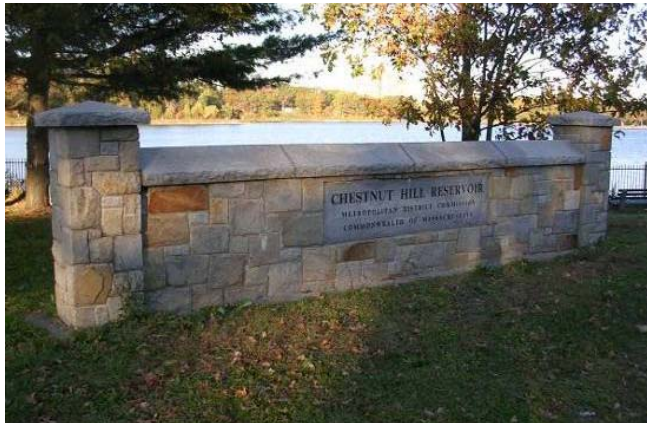
Most of the mortar joints for all three walls are in good condition, but deterioration is starting to affect the masonry. Almost all of the capstone butt joints have small cracks and some moss is taking hold at the butt joints that absorb moisture and dry slowly. A few of the joints between the stone units show calcium carbonate deposits. Water infiltration is beginning to work into the wall but no significant damage has occurred yet.

Figure 3.13: Freestanding stone wall at Beacon Street Entrance (2005)

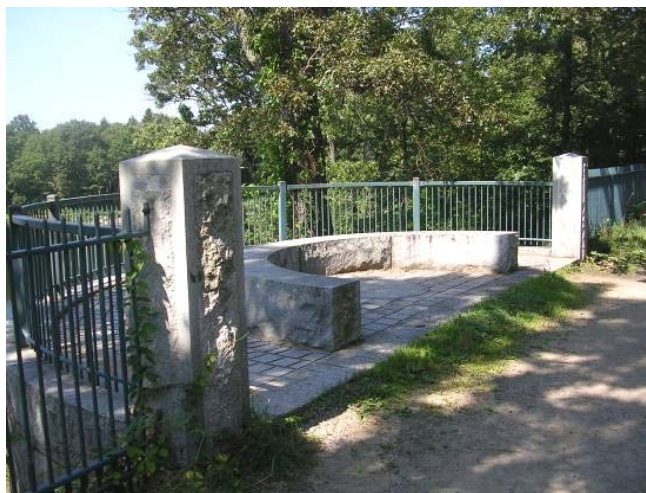
The overlook and all its associated features are in fair to good condition. However, there is a slight step-down to the adjacent packed dirt pathway that presents a tripping hazard as well as being aesthetically unattractive. This also effectively makes the overlook inaccessible to persons with physical disabilities.

Figure 3.16: 1977 overlook (2005)

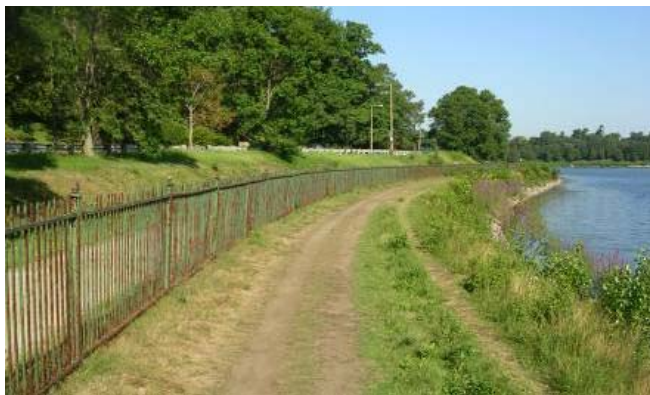
Figure 3.22: Worn dirt path running inside the perimeter fence and alongside Beacon Street (2005)

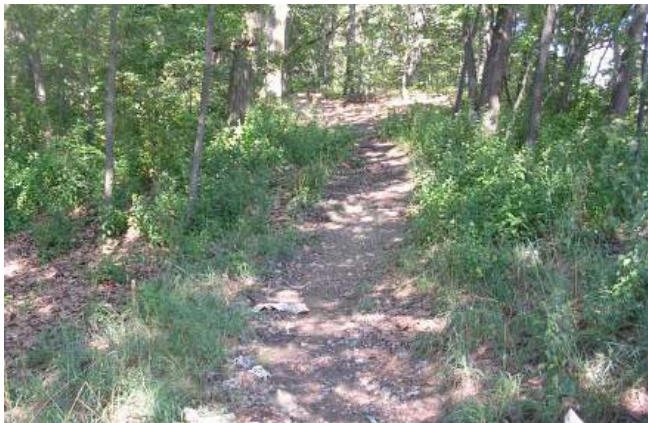
Figure 3.24: Desire line on drumlin in northeast corner of the Reservation (2005)

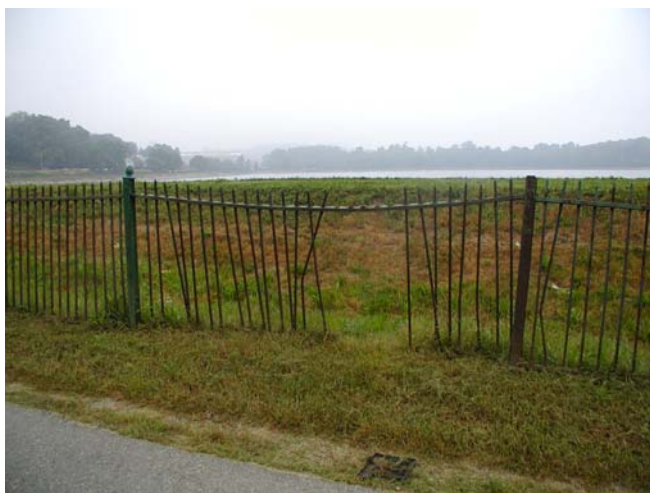
The 1928-29 fence design consists of panels of twenty-one square section balusters between I-section posts with acorn-styled finials and tied by two horizontal L-section bars. The panels are eight-four inches (seven feet) long. Each panel includes a top and bottom rail made of two inch wide channels laid flat and five-eighth of an inch square by fifty-four inch long pointed pickets spaced four inches apart. The ends of each top and bottom rail have an elongated hole where they are bolted to the posts, thereby allowing the panels to slip slightly as the fencing expands and contracts during temperature changes. Unlike many old iron and steel fences at cemeteries and other historic sites, only a few of the failed connections have been repaired with welds, which prevent the relieving slippage between each post. The 1977 fencing panels were designed in a similar style to the 1928-29 originals, but they are one hundred and twenty inches (ten feet) long and do not have the decorative acorn castings. The new 1977 metal fencing is green although most of the panels have severely peeling paint.

Figure 3.29: Typically damaged 1928-29 panels (2005)

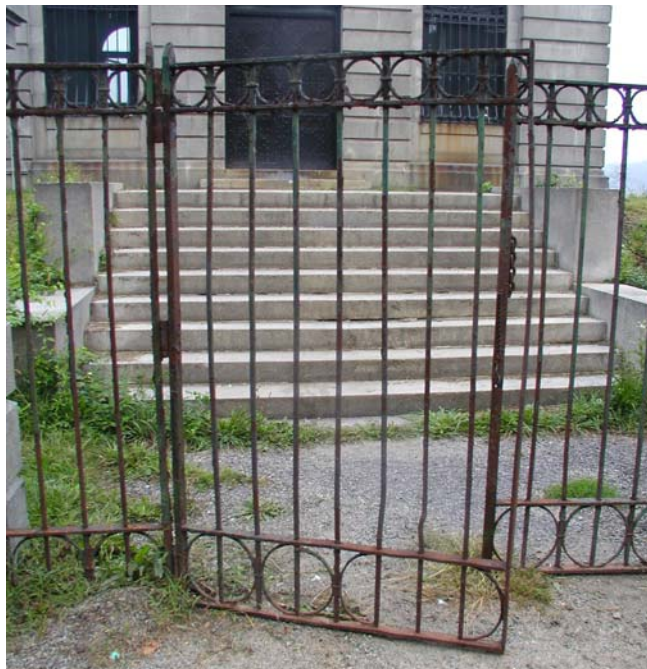
Figure 3.32: Gatehouse #2 gate with missing circular elements (2005)

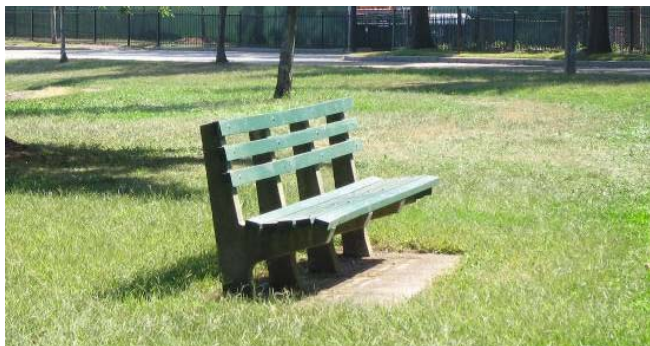
Figure 3.35: Type 1 bench (2005)

These benches are generally in fair condition with mostly maintenance and small repairs needed such as painting the wood slats. The Type 1 benches are well-sited in the landscape and are directed toward views of the Reservoir.

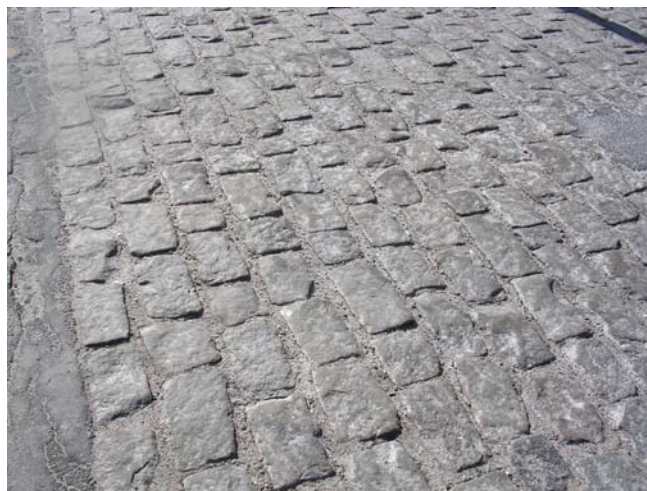
Figure 5.6: Cobblestone strips proposed to be removed along Chestnut Hill Driveway (2006)

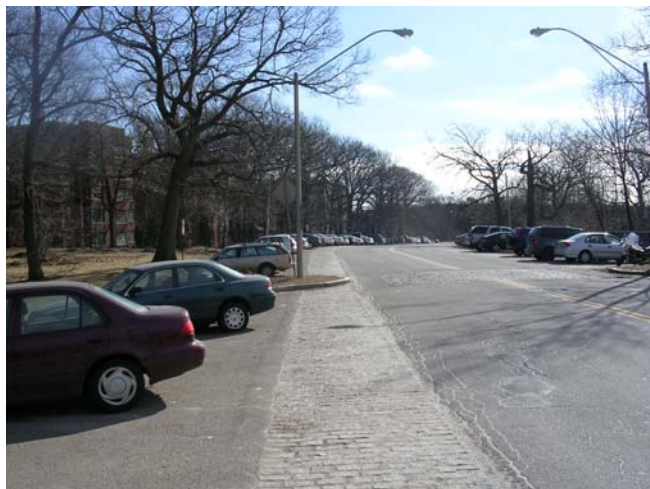
Figure 5.7: Parking spaces along Chestnut Hill Driveway proposed to be removed (2005)

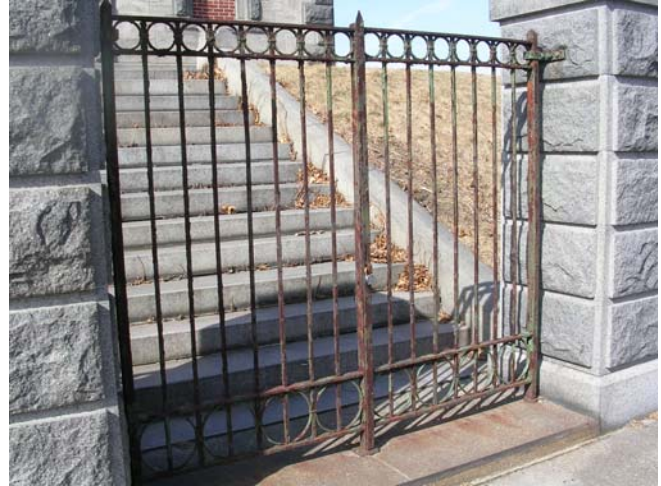
Figure 5.8: Gatehouse #2 fence gates proposed to be repaired and restored (2005)

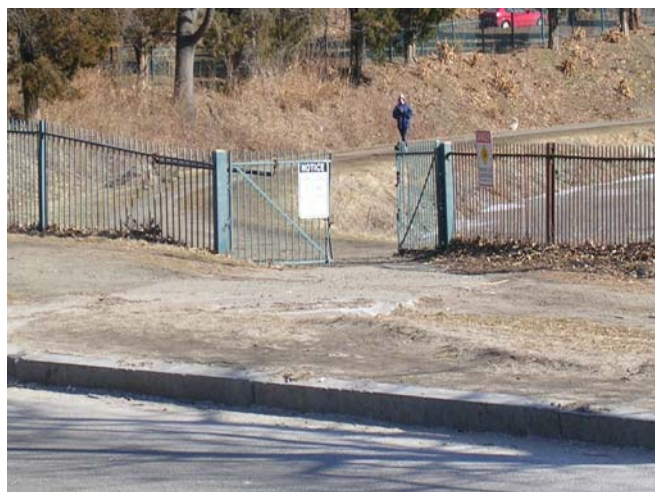
Figure 5.9: 1977 gate in the perimeter fence proposed to be removed (2006)

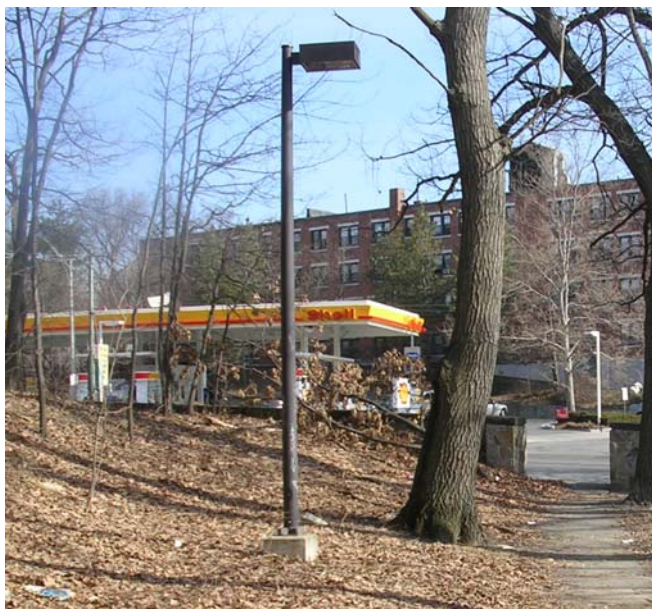
Figure 5.10: Park lights proposed to be removed on the hill behind Reilly Pool & Rink (2006)
